**Flood Control Project Maintenance
Levee Inspections**

Maintenance Issue Types Only, Levee Inspection Report By Mile - Spring 2017

Reclamation District No. 2095 Paradise Cut

Waterway	Bank	Unit Miles	Inspection Start/End	Inspector
Unit No. 01 Paradise Cut	Left	1.45	04/18/2017 04/18/2017	Maksim Khashchuk

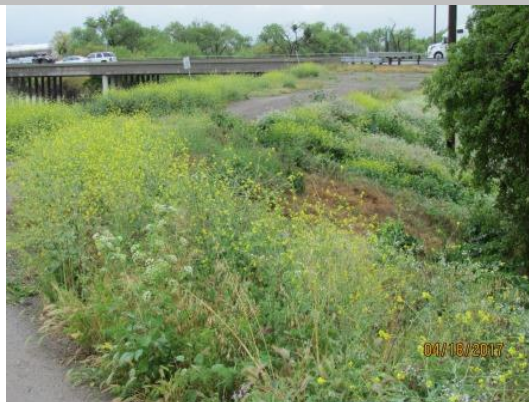
Photo 1 of 1 : SP_2017_RD2095_322_8_20170421_00027.jpg

LM Start	0.05	Rating **	M	Issue No.	8
LM End	0.10	Issue Type +	Ma	Location *	LS
Category	Earthen Levee			GPS Latitude/Longitude	
				Start	End
Item	Vegetation			37.770586 °	37.770223 °
				-121.326571 °	-121.325832 °
DWR ID	DWR_RD2095_01_s_2017_8				
Comment Code					
V1 : Control annual grass and weeds on the levee slopes and easements.					
Inspector Comment

View of the vegetation on the levee slope.

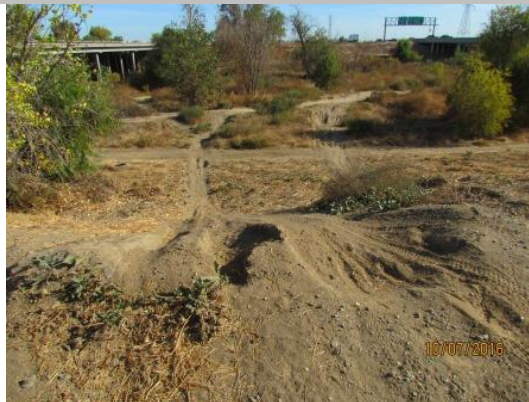
Photo 1 of 2 : SP_2017_RD2095_322_3_20170407_00004.jpg

LM Start	0.08	Rating **	M	Issue No.	3
LM End	0.08	Issue Type +	Ma	Location *	WS
Category	Earthen Levee			GPS Latitude/Longitude	
				Start	End
Item	Slope Stability			37.770528 °	37.770528 °
				-121.326198 °	-121.326198 °
DWR ID	DWR_RD2095_01_s_2016_3				
Comment Code					
S3 : Repair the levee slope damaged by vehicle traffic and prevent access where possible.					
Inspector Comment

Recent view of the vehicle tracks on the waterside levee slope.

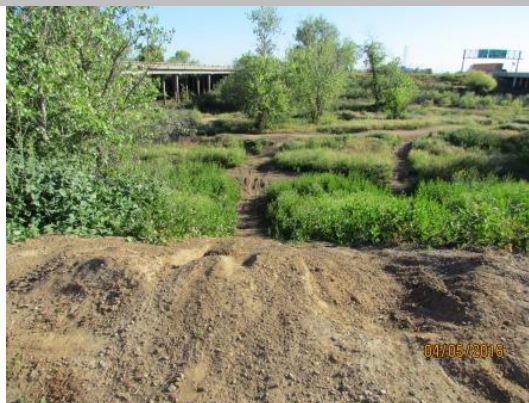
Photo 2 of 2 : SP_2017_RD2095_322_3_20170407_00005.jpg

LM Start	0.08	Rating **	M	Issue No.	3 (cont)	
LM End	0.08	Issue Type +	Ma	Location *	WS	
Category	Earthen Levee			GPS Latitude/Longitude		
				Start		End
Item	Slope Stability			37.770528 °		37.770528 °
				-121.326198 °		-121.326198 °
DWR ID	DWR_RD2095_01_s_2016_3					
Comment Code						
S3 : Repair the levee slope damaged by vehicle traffic and prevent access where possible.						
Inspector Comment

View of the vehicle tracks on the waterside levee slope.

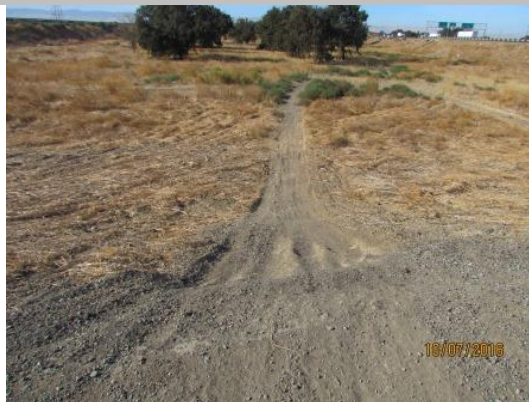
Photo 1 of 2 : SP_2017_RD2095_322_12_20170407_00010.jpg

LM Start	0.09	Rating **	M	Issue No.	12
LM End	0.09	Issue Type +	Ma	Location *	LS
Category	Earthen Levee			GPS Latitude/Longitude	
				Start	End
Item	Slope Stability			37.770429°	37.770429°
				-121.325986°	-121.325986°
DWR ID	DWR_RD2095_01_s_2016_12				
Comment Code					
S3 : Repair the levee slope damaged by vehicle traffic and prevent access where possible.					
Inspector Comment

Recent view of the vehicle tracks on the landside levee slope.

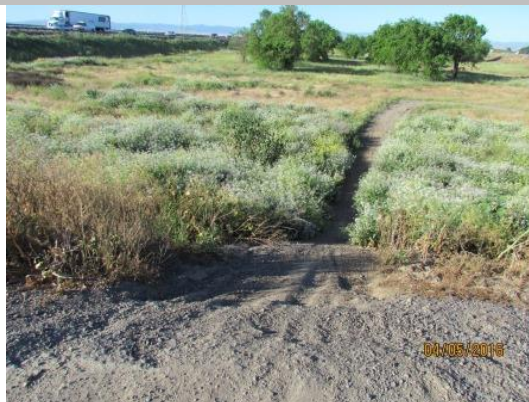
Photo 2 of 2 : SP_2017_RD2095_322_12_20170407_00011.jpg

View of the vehicle tracks on the landside levee slope.

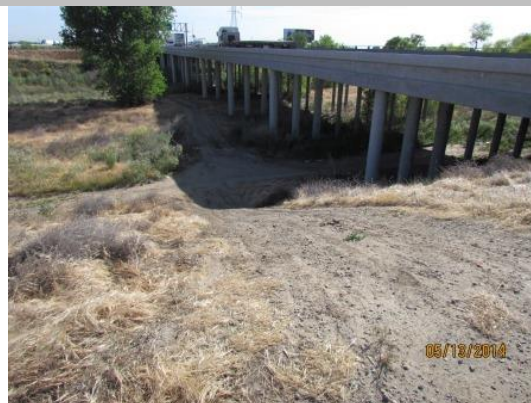
Photo 1 of 1 : SP_2017_RD2095_322_134_20170407_00012.jpg

LM Start	0.11	Rating **	M	Issue No.	134
LM End	0.11	Issue Type +	Ma	Location *	WS
Category	Earthen Levee			GPS Latitude/Longitude	
				Start	End
Item	Slope Stability			37.770212°	37.770212°
				-121.325675°	-121.325675°
DWR ID	DWR_RD2095_01_s_2014_134				
Comment Code					
S3 : Repair the levee slope damaged by vehicle traffic and prevent access where possible.					
Inspector Comment

View of the vehicle access on the waterside levee slope.

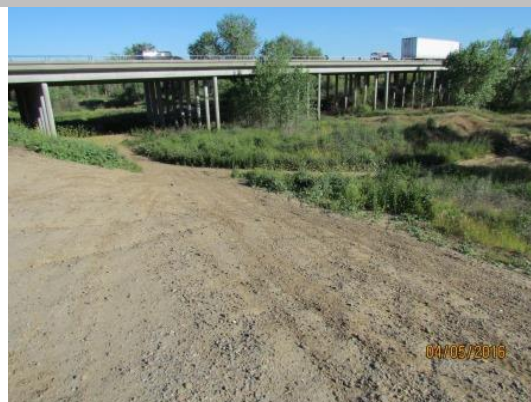
Photo 1 of 1 : SP_2017_RD2095_322_10_20170407_00008.jpg

LM Start	0.15	Rating **	M	Issue No.	10
LM End	0.15	Issue Type +	Ma	Location *	WS
Category	Earthen Levee			GPS Latitude/Longitude	
				Start	End
Item	Slope Stability			37.769997°	37.769997°
				-121.325055°	-121.325055°
DWR ID	DWR_RD2095_01_f_2015_10				
Comment Code					
S3 : Repair the levee slope damaged by vehicle traffic and prevent access where possible.					
Inspector Comment					
LMA is actively controlling access.

View of the vehicle tracks on the waterside levee slope.

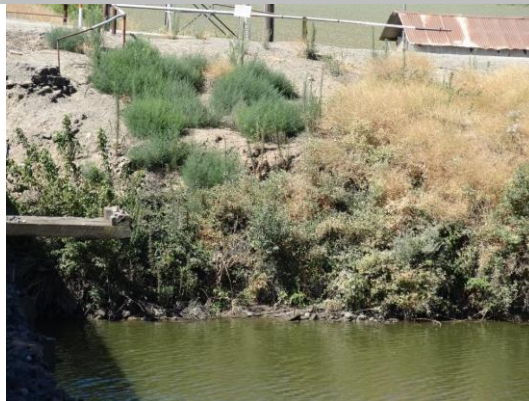
Photo 1 of 3 : SP_2017_RD2095_322_1_20170407_00001.jpg

LM Start	0.72	Rating **	M	Issue No.	1
LM End	0.73	Issue Type +	Ma	Location *	WS
Category	Supplemental			GPS Latitude/Longitude	
				Start	End
Item	DWR Erosion Survey			37.763630 °	37.763630 °
				-121.319000 °	-121.319000 °
DWR ID	DWR RD2095 01 s 2017 1

07/20/2016: No significant change observed.
 08/04/2015: No significant change observed.
 08/26/2014: No significant change observed.
 08/28/2013: No significant change observed.
 07/18/2012: No significant change observed.
 09/02/2011: No significant change observed.
 09/22/2010: No significant change observed. There is now considerable vegetation at the water line and along the lower berm slope. However, the erosion on the lower berm slope is still present and has not been corrected.
 08/06/2010: Recommended for local maintenance issue, per CLRO.
 07/29/2009: No major change since last visit; noticeable vegetation growth; erosion is on berm, but if left untreated, it will eventually erode into levee prism; site is recommended for annual assessment and monitoring of the site, per CLRO CES 2008 Report; Site # is the same as RM6.80, LM0.73; previously rated "U".
 07/22/2008: Downstream of WPRR near siphon pipe & pump; sandy levee; visited by Jeff Van Gilder and LRO in 2008 for repair assessment; scouring downstream of RR crossing, possibly caused by eddy effects.

Looking at the erosion from the RR bridge.

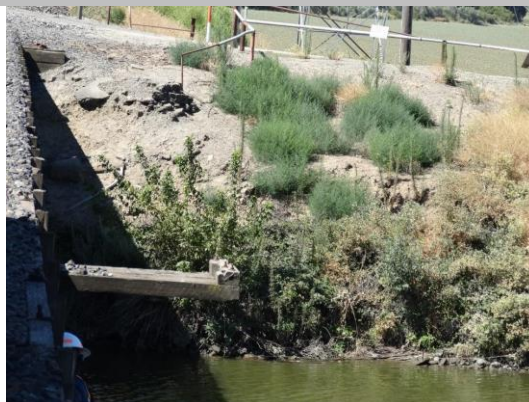
Photo 2 of 3 : SP_2017_RD2095_322_1_20170407_00002.jpg

Looking down at the erosion downstream of the RR bridge.

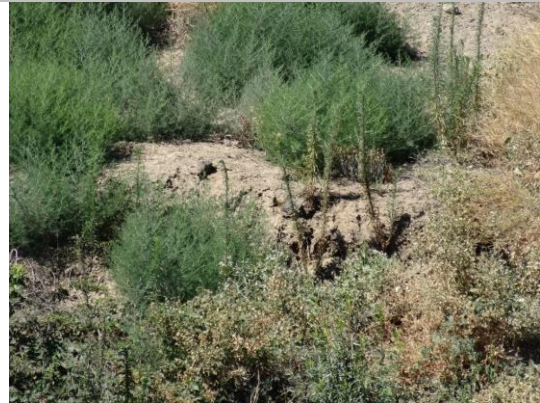
Photo 3 of 3 : SP_2017_RD2095_322_1_20170407_00003.jpg

Comment Code						
Inspector Comment						
07/20/2016: No significant change observed.						
08/04/2015: No significant change observed.						
08/26/2014: No significant change observed.						
08/28/2013: No significant change observed.						
07/18/2012: No significant change observed.						
09/02/2011: No significant change observed.						
09/22/2010: No significant change observed. There is now considerable vegetation at the water line and along the lower berm slope. However, the erosion on the lower berm slope is still present and has not been corrected.						
08/06/2010: Recommended for local maintenance issue, per CLRO.						
07/29/2009: No major change since last visit; noticeable vegetation growth; erosion is on berm, but if left untreated, it will eventually erode into levee prism; site is recommended for annual assessment and monitoring of the site, per CLRO CES 2008 Report; Site # is the same as RM6.80,LM0.73; previously rated "U".

07/22/2008: Downstream of WPRR near siphon pipe & pump; sandy levee; visited by Jeff Van Gilder and LRO in 2008 for repair assessment; scouring downstream of RR crossing, possibly caused by eddy effects.						
03/13/2007: Site visited on 03/13/2007. [2016 Site ID:RD2095U01RM6.74]

Close view of the erosion downstream of the RR ridge.

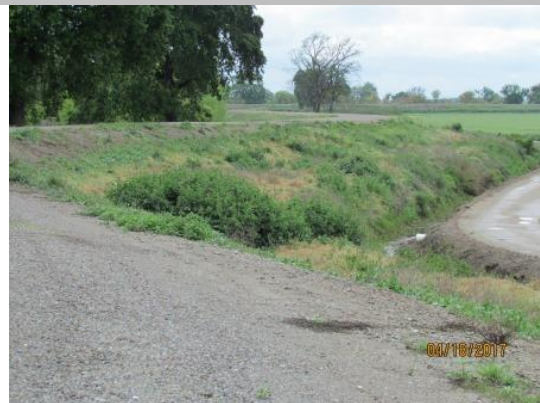
Photo 1 of 1 : SP_2017_RD2095_322_9_20170421_00028.jpg

LM Start	0.90	Rating **	M	Issue No.	9
LM End	1.44	Issue Type +	Ma	Location *	LS
Category	Earthen Levee			GPS Latitude/Longitude	
				Start	End
Item	Vegetation			37.761128 °	37.759201 °
				-121.317645 °	-121.308517 °
DWR ID	DWR_RD2095_01_f_2016_9				
Comment Code					
V1 : Control annual grass and weeds on the levee slopes and easements.					
Inspector Comment

View of the vegetation on the landside levee slope and toe.

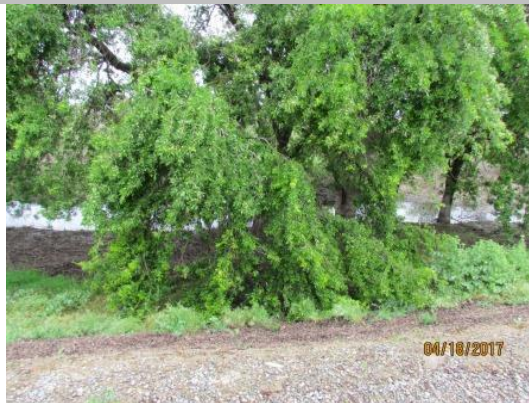
Photo 1 of 1 : SP_2017_RD2095_322_13_20170421_00029.jpg

LM Start	1.27	Rating **	M	Issue No.	13
LM End	1.27	Issue Type +	Ma	Location *	WS
Category	Earthen Levee			GPS Latitude/Longitude	
				Start	End
Item	Trim / Thin Trees			37.759477 °	37.759477 °
				-121.311564 °	-121.311564 °
DWR ID	DWR_RD2095_01_s_2017_13				
Comment Code					
T1 : Trim trees to at least five feet above ground level.					
Inspector Comment

View of the tree limbs that need to be trimmed.

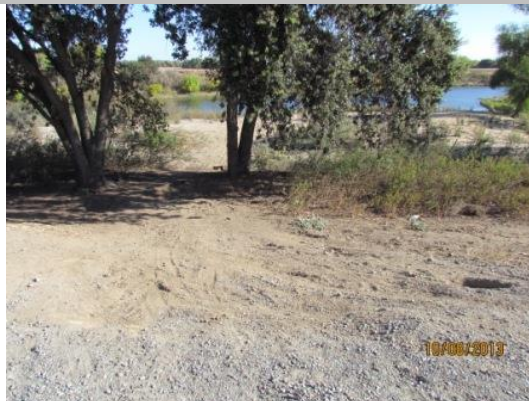
Photo 1 of 1 : SP_2017_RD2095_323_9_20170407_00008.jpg

LM Start	0.03	Rating **	A/W	Issue No.	9
LM End	0.03	Issue Type +	Ma	Location *	WS
Category	Earthen Levee			GPS Latitude/Longitude	
				Start	End
Item	Slope Stability			37.758986 °	37.758986 °
				-121.307854 °	-121.307854 °
DWR ID	DWR_RD2095_02_s_2013_9				
Comment Code					
S3 : Repair the levee slope damaged by vehicle traffic and prevent access where possible.					
Inspector Comment

View of the vehicle tire ruts on waterside levee slope.

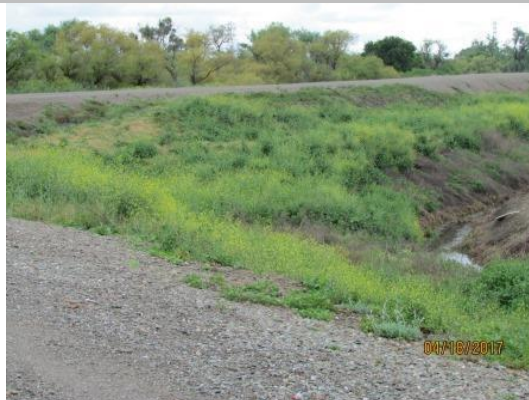
Photo 1 of 1 : SP_2017_RD2095_323_15_20170421_00028.jpg

LM Start	0.04	Rating **	M	Issue No.	15
LM End	0.64	Issue Type +	Ma	Location *	LS
Category	Earthen Levee			GPS Latitude/Longitude	
				Start	End
Item	Vegetation			37.758894 °	37.751095 °
				-121.307741 °	-121.304251 °
DWR ID	DWR_RD2095_02_f_2016_15				
Comment Code					
V1 : Control annual grass and weeds on the levee slopes and easements.					
Inspector Comment

View of the vegetation on the landside levee slope.

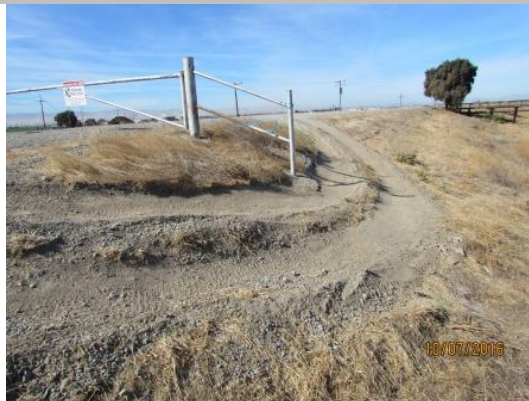
Photo 1 of 2 : SP_2017_RD2095_323_11_20170407_00009.jpg

LM Start	0.82	Rating **	M	Issue No.	11
LM End	0.82	Issue Type +	Ma	Location *	WS
Category	Earthen Levee			GPS Latitude/Longitude	
				Start	End
Item	Slope Stability			37.749644 °	37.749644 °
				-121.301960 °	-121.301960 °
DWR ID	DWR_RD2095_02_s_2016_11				
Comment Code					
S3 : Repair the levee slope damaged by vehicle traffic and prevent access where possible.					
Inspector Comment

Recent view of the vehicle tracks on the waterside levee slope, facing downstream.

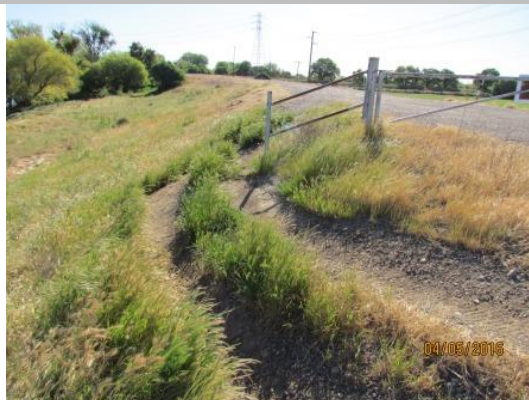
Photo 2 of 2 : SP_2017_RD2095_323_11_20170407_00010.jpg

View of the vehicle tracks on the waterside levee slope.

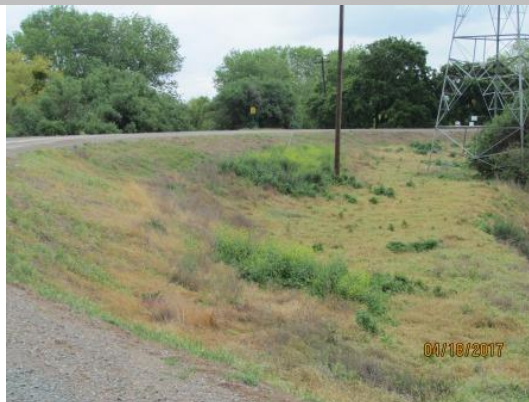
Photo 1 of 1 : SP_2017_RD2095_323_18_20170421_00029.jpg

LM Start	0.87	Rating **	M	Issue No.	18
LM End	1.07	Issue Type +	Ma	Location *	LS
Category	Earthen Levee			GPS Latitude/Longitude	
				Start	End
Item	Vegetation			37.749635 °	37.748455 °
				-121.300948 °	-121.298987 °
DWR ID	DWR_RD2095_02_f_2016_18				
Comment Code					
V1 : Control annual grass and weeds on the levee slopes and easements.					
Inspector Comment

View of the vegetation on the landside levee slope.

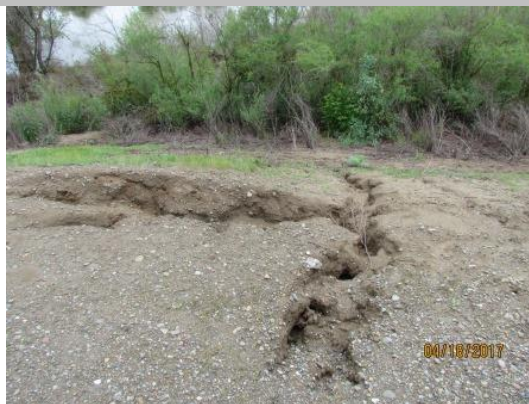
Photo 1 of 1 : SP_2017_RD2095_323_22_20170421_00030.jpg

LM Start	0.94	Rating **	M	Issue No.	22
LM End	0.94	Issue Type +	Ma	Location *	WS
Category	Earthen Levee			GPS Latitude/Longitude	
				Start	End
Item	Erosion / Bank Caving			37.749840 °	37.749840 °
				-121.299705 °	-121.299705 °
DWR ID	DWR_RD2095_02_s_2017_22				
Comment Code					
E2 : Schedule repair of erosion site prior to the next inspection.					
Inspector Comment

View of the erosion on the levee slope.

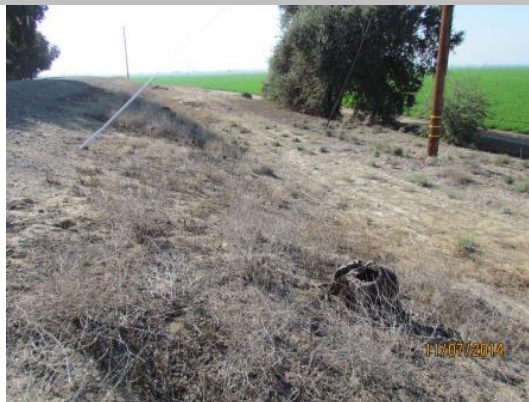
Photo 1 of 1 : SP_2017_RD2095_323_3_20170407_00006.jpg

View of the tree stumps on the landside levee slope..

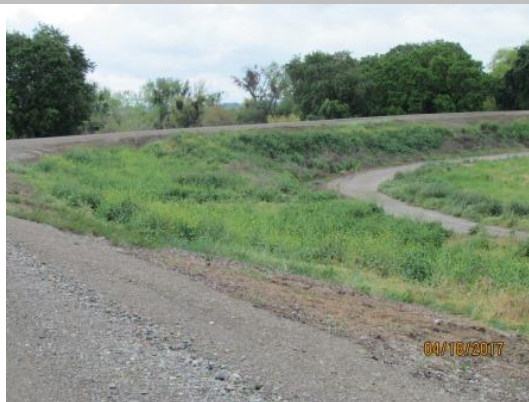
Photo 1 of 1 : SP_2017_RD2095_323_23_20170421_00031.jpg

LM Start	1.23	Rating **	M	Issue No.	23
LM End	2.52	Issue Type +	Ma	Location *	LS
Category	Earthen Levee			GPS Latitude/Longitude	
				Start	End
Item	Vegetation			37.746268 °	37.729439 °
				-121.298501 °	-121.299053 °
DWR ID	DWR_RD2095_02_s_2017_23				
Comment Code					
V1 : Control annual grass and weeds on the levee slopes and easements.					
Inspector Comment

View of the vegetation on the landside levee slope.

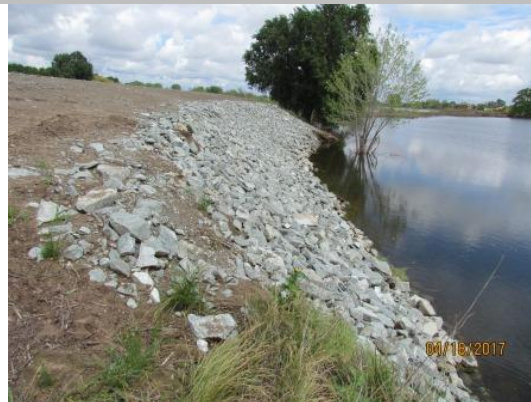
Photo 1 of 2 : SP_2017_RD2095_323_195_20170421_00032.jpg

LM Start	1.35	Rating **	A/W	Issue No.	195
LM End	1.35	Issue Type +	Ma	Location *	WS
Category	Earthen Levee			GPS Latitude/Longitude	
				Start	End
Item	Erosion / Bank Caving			37.744746 °	37.744746 °
				-121.297695 °	-121.297695 °
DWR ID	DWR_RD2095_02_s_2014_195				
Comment Code					
E1 : Note and monitor erosion site.					
Inspector Comment					
Erosion site repaired February 2017.

View of the repaired erosion site. Spring 2017.

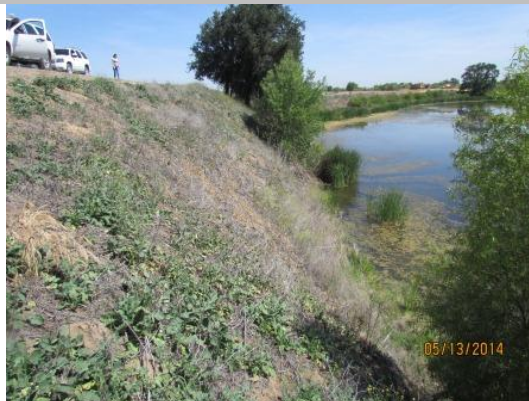
Photo 2 of 2 : SP_2017_RD2095_323_195_20170407_00018.jpg

LM Start	1.35	Rating **	A/W	Issue No.	195 (cont)	
LM End	1.35	Issue Type +	Ma	Location *	WS	
Category	Earthen Levee			GPS Latitude/Longitude		
				Start		End
Item	Erosion / Bank Caving			37.744746 °	37.744746 °	
				-121.297695 °	-121.297695 °	
DWR ID	DWR_RD2095_02_s_2014_195					
Comment Code						
E1 : Note and monitor erosion site.						
Inspector Comment						
Erosion site repaired February 2017.

View of the erosion on the waterside levee slope possibly eroding into the levee prism.

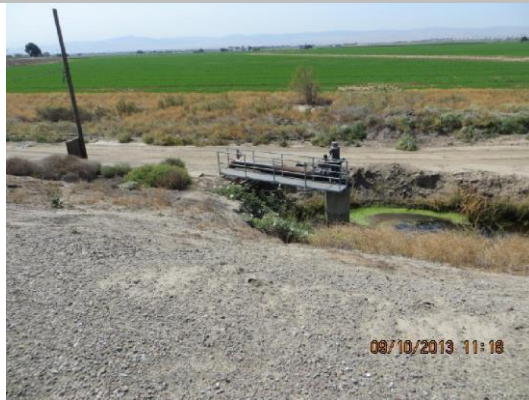
Photo 1 of 1 : UCIP_SP_2017_19863_33760.jpg

LM Start	1.48	Rating **	M	Issue No.	942
LM End	1.48	Issue Type +	Ma	Location *	WS
Category	Supplemental			GPS Latitude/Longitude	
				Start	End
Item	DWR UCIP LMA Responsibility			37.743142 °	37.743142 °
				-121.297692 °	-121.297692 °
DWR ID					
Comment Code					
Inspector Comment					
FS_ID:19863					
DS_ID:21642					
EP_NO: 4658					
Repair Type: Non-Urgent					
Crossing Status: Found					
UCIP Comments: Pipe appears abandoned in place and re-routed to LM 1.652. Need to verify pipe was properly abandoned. Permit FIELD_STRUCT_DESC: *ABANDONED* 14-inch pipe through levee 3.5-feet below crown. Pump on structure over drain ditch on the landward side. Flap gate on the waterward end (Permit No. 4658). Originally included in the 1968 O&M manual.					
FS Date: 9/10/2013

Pump visible on LS toe, but pipe has been re-routed to southwest.

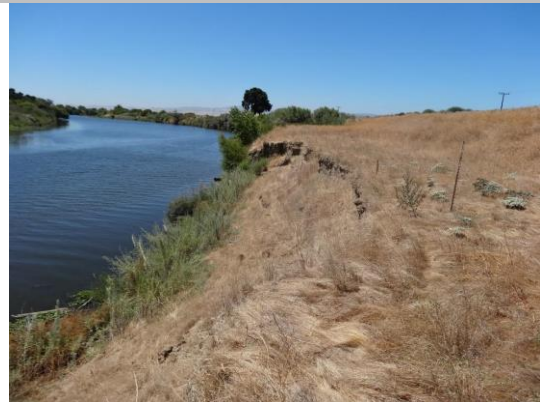
Photo 1 of 3 : SP_2017_RD2095_323_1_20170407_00001.jpg

Comment Code					
Inspector Comment					
07/20/2016: The erosion extended toward the levee toe. The berm width was reduced by approximately five (5) feet.					
08/04/2015: No significant change observed.					
07/02/2014: No significant change observed.					
08/28/2013: No significant change observed.					
09/13/2012: The site has been visited by land survey. The vegetation on the site shows the erosion has not developed significantly from the last survey.					
The site was not visited by boat survey due to the limitation of navigable waterway.					
08/23/2011: No significant change observed.					
9/22/2010: No significant change observed. There is moderate vegetation growth on the berm. Despite the erosion occurring on the berm, corrective action should be taken before the issue becomes severe.					
9/29/2009: Site is immediately downstream of a section of existing rip rap; there is a 20-foot berm remaining; berm will continue to erode unless erosion is mitigated; Site# is the same as RM62.6, LM1.87; recommended for annual assessment, per CES Evaluation 2008 Report

2006: Visited 10/20/06 [2016 Site ID:RD2095U02RM60.62]

Looking at the erosion from downstream of the site.

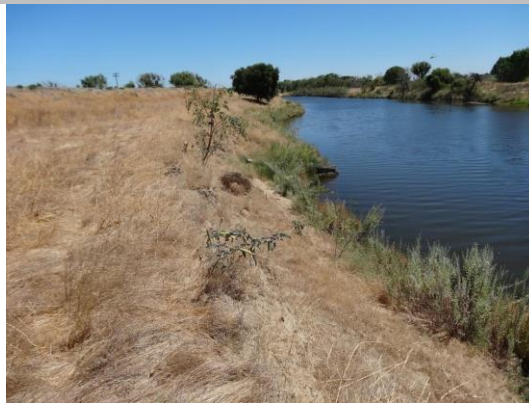
Photo 2 of 3 : SP_2017_RD2095_323_1_20170407_00002.jpg

9/22/2010: No significant change observed. There is moderate vegetation growth on the berm. Despite the erosion occurring on the berm, corrective action should be taken before the issue becomes severe.

9/29/2009: Site is immediately downstream of a section of existing rip rap; there is a 20-foot berm remaining; berm will continue to erode unless erosion is mitigated; Site# is the same as RM62.6, LM1.87; recommended for annual assessment, per CES Evaluation 2008 Report 2006: Visited 10/20/06 [2016 Site ID:RD2095U02RM60.62]

Looking at the erosion from upstream of the site

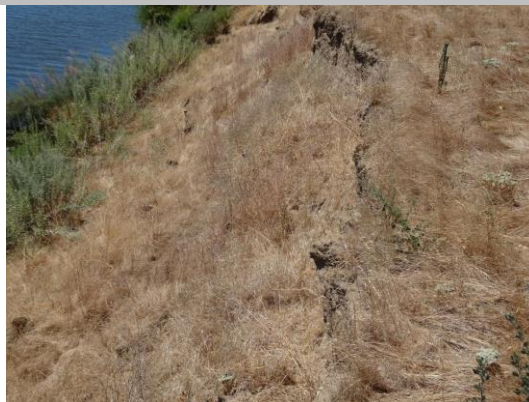
Photo 3 of 3 : SP_2017_RD2095_323_1_20170407_00003.jpg

Close view of the site.

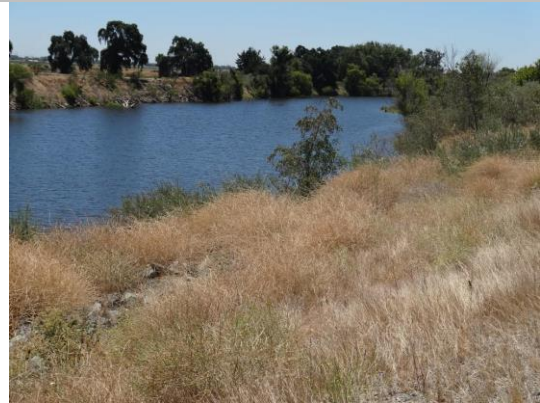
Photo 2 of 2 : SP_2017_RD2095_323_2_20170407_00005.jpg

Comment Code						
Inspector Comment						
07/20/2016: No significant change observed. Dense vegetation blocks the visual inspection at the site.						
08/04/2015: No significant change observed.						
7/02/2014: No significant change observed.						
08/28/2013: No significant change observed. Dense vegetation blocks the visual inspection at the site.						
09/13/2012: The site has been visited by land survey. The erosion is not visible from the levee slope because of dense vegetation at the site. Levee slope is protected by placed rocks. The site was not visited by boat survey due to the limitation of navigable waterway.						
08/23/2011: Dense vegetation makes it difficult to view the possible erosion. No new development was observed on site.						
09/23/2010: At the time of the inspection, the erosion site was difficult to view from the levee. The erosion is located on the bank toe, below the existing rip rap. There were no signs of repair on site, nor has the site been reported to be repaired by the district. Images taken from last year indicate that existing rip rap at the bank toe has sloughed exposing the underlying soils. Weakening of the toe could lead to future bank instability.

08/05/2010: Recommended for annual assessment and monitoring during flood events, per CLRO.						
09/29/2009: No major change observed since last visit; sloughing of the rip rap above toe; erosion begins immediately downstream of existing rip rap revetment; roughly 15-foot berm remains; however, it will continue to erode and eventually intrude into the levee profile if left untreated.						
10/20/2006: Just upstream of where berm starts to widen. [2016 Site ID:RD2095U02RM60.69]

The erosion is not visible from the levee top. The levee slope is protected by riprap rocks.

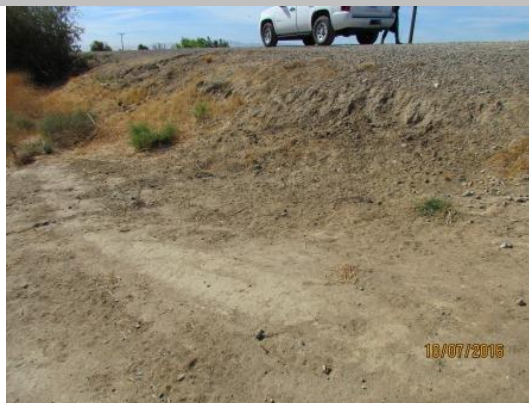
Photo 1 of 2 : SP_2017_RD2095_323_19_20170407_00014.jpg

LM Start	2.09	Rating **	M	Issue No.	19
LM End	2.09	Issue Type +	Ma	Location *	WS
Category	Earthen Levee			GPS Latitude/Longitude	
				Start	End
Item	Slope Stability			37.735276 °	37.735276 °
				-121.297777 °	-121.297777 °
DWR ID	DWR_RD2095_02_f_2016_19				
Comment Code					
S1 : Repair slope instability.					
Inspector Comment

View of the erosion on the waterside levee slope.

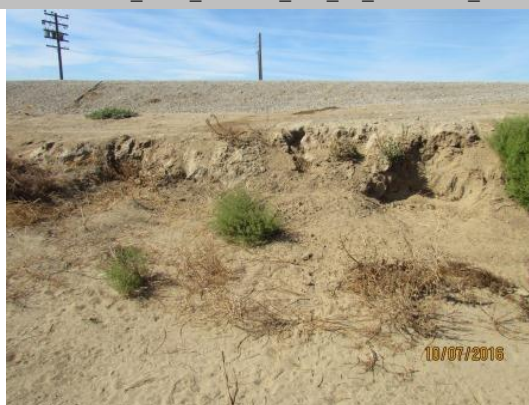
Photo 2 of 2 : SP_2017_RD2095_323_19_20170407_00015.jpg

View of the erosion caused by excavation on the waterside levee slope.

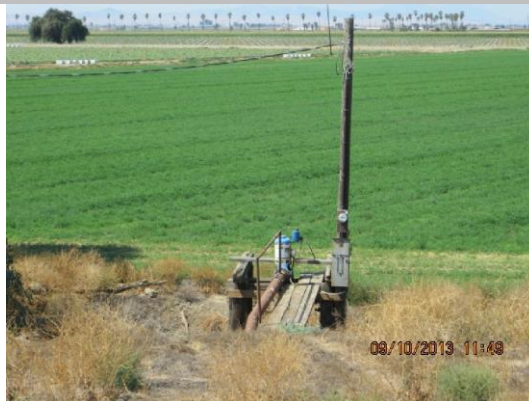
Photo 1 of 2 : UCIP_SP_2017_19871_33778.jpg

LM Start	2.38	Rating **	A/W	Issue No.	945
LM End	2.38	Issue Type +	Ma	Location *	WS
Category	Supplemental			GPS Latitude/Longitude	
				Start	End
Item	DWR UCIP LMA Responsibility			37.731313 °	37.731313 °
				-121.298298 °	-121.298298 °
DWR ID					
Comment Code					
Inspector Comment					
FS_ID:19871 DS_ID:21644 EP_NO: N/A Repair Type: No Action Needed Crossing Status: Found UCIP Comments: FIELD_STRUCT_DESC: 8-inch steel stormdrain pipe through the levee 3.0-feet below the crown. Pump in drain ditch on the landward side. Vent pipe at the toe of the waterward slope. 1.5-inch galvanized iron electrical conduit through levee at same location. Service pole with switch box and meter on the landward side. Originally included in the 1968 O&M manual. FS Date: 9/10/2013

Pump on metal pier off LS toe.

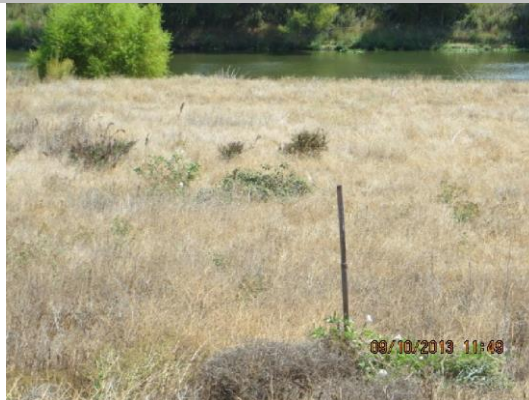
Photo 2 of 2 : UCIP_SP_2017_19871_33777.jpg

Vent standpipe on WS toe.

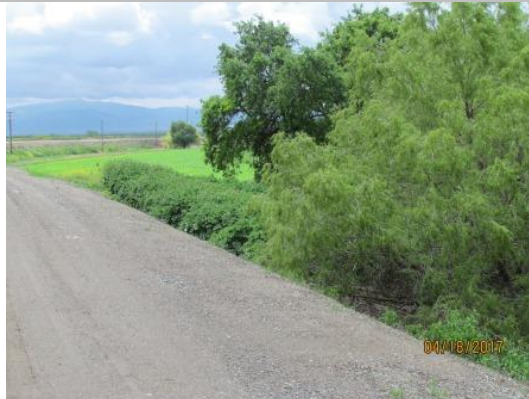
Photo 1 of 1 : SP_2017_RD2095_323_24_20170421_00034.jpg

View of the vegetation on the landside levee slope.

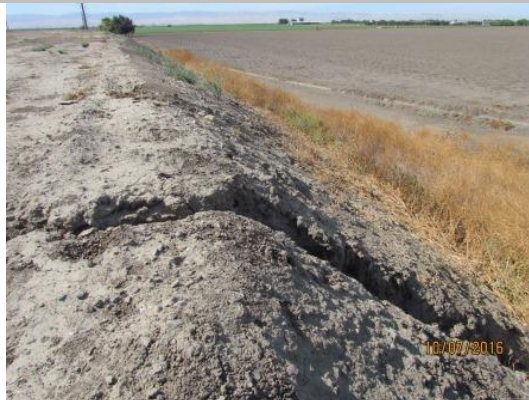
Photo 1 of 2 : SP_2017_RD2095_323_21_20170407_00016.jpg

LM Start	2.85	Rating **	M	Issue No.	21
LM End	2.85	Issue Type +	Ma	Location *	LS
Category	Earthen Levee			GPS Latitude/Longitude	
				Start	End
Item	Erosion / Bank Caving			37.724647 °	37.724647 °
				-121.299749 °	-121.299749 °
DWR ID	DWR_RD2095_02_f_2016_21				
Comment Code					
E2 : Schedule repair of erosion site prior to the next inspection.					
Inspector Comment

View of the landside levee slope erosion.

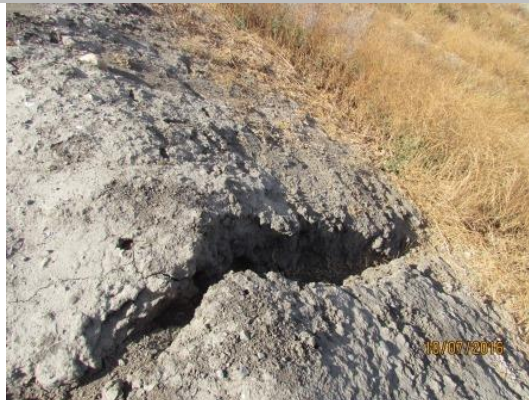
Photo 2 of 2 : SP_2017_RD2095_323_21_20170407_00017.jpg

Another view of the landside levee slope erosion.
